# Shuttle Rudder/Speed Brake Power Drive Unit (PDU) Gear Scuffing Tests With Flight Gears

Margaret P. Proctor and Fred B. Oswald  
Glenn Research Center, Cleveland, Ohio

Timothy L. Krantz  
U.S. Army Research Laboratory, Glenn Research Center, Cleveland, Ohio

## **Abstract**

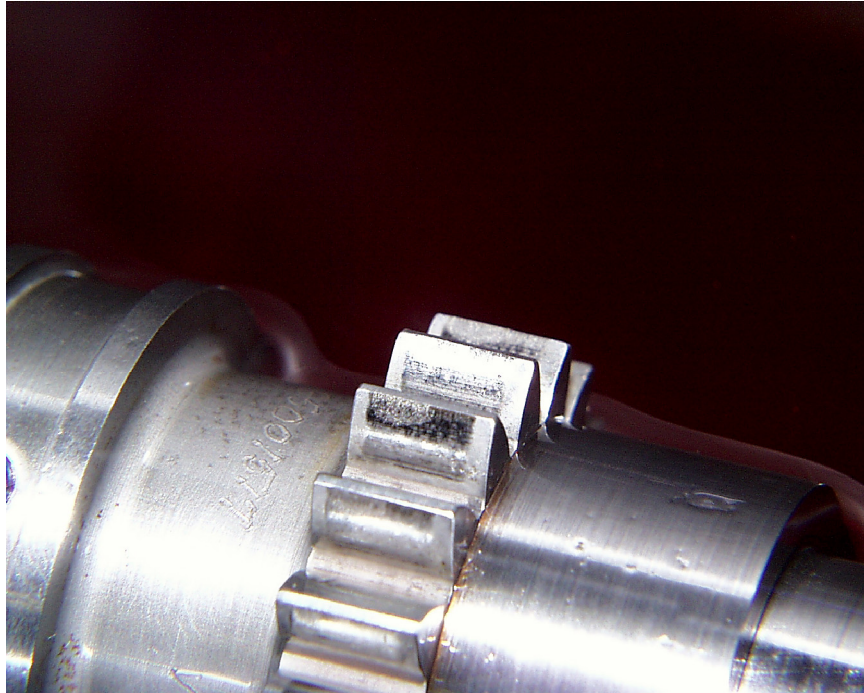
It is interesting to note the fling temperature shows a sudden increase at approximately 300 sec. Just prior to this there is a spike in both the pinion and ring gear vibration and an instability in the input torque and speed measurements. This may indicate the time when the wear marks were created.

Visual inspection after the Back-3c test found half-moon-shaped wear marks near the tip of the driven side of all pinion gear teeth (fig. 12). These wear marks were slightly offset from the tooth center towards the drive motor. There were corresponding marks on the driving side of the ring gear teeth near the root (fig. 13). While the wear pattern is similar to the scuffing found on the shuttle flight gears, it is much less severe. The mark had no depth perceptible to touch.

Figure 12.—Wear marks on driven side of pinion gear teeth after Back-3c.

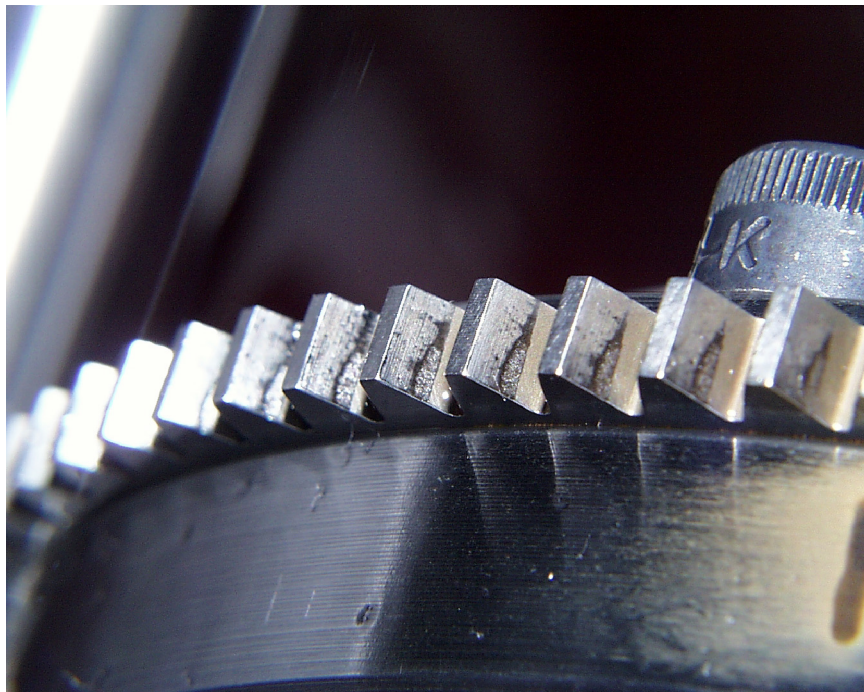
Figure 13.—Wear marks on driving side of ring gear teeth after Back-3c.

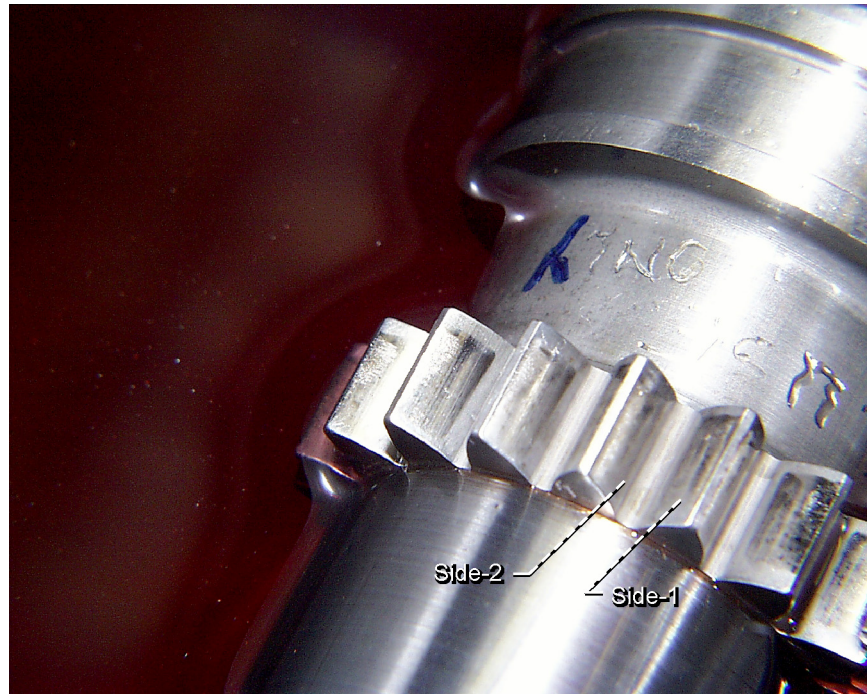
Small wear marks near the tips of the driven side of the pinion teeth (fig. 15), were generated during the Score-1 test on side-2, build-1 conducted at input speed, torque, and power of 2865 rpm, 1167 in.-lb, and 53 hp. No corresponding wear was observed on the ring gear teeth as shown in figure 16. The time histories of input speed, input torque, oil fling temperature, and pinion vibration are shown in figure 17. There is no distinct corroboration of vibration rise and fling temperature rise as in the Back-3c test. There are some high vibration levels in the test however. The drop in oil fling temperature is likely due to turning off the heat gun and heat lamp prior to rotation and some initial cooling due to flinging the oil to cooler surfaces above the oil bath.

Figure 15.—Wear marks on driven side of pinion gear teeth after Score-1 test on side-2, build-1.

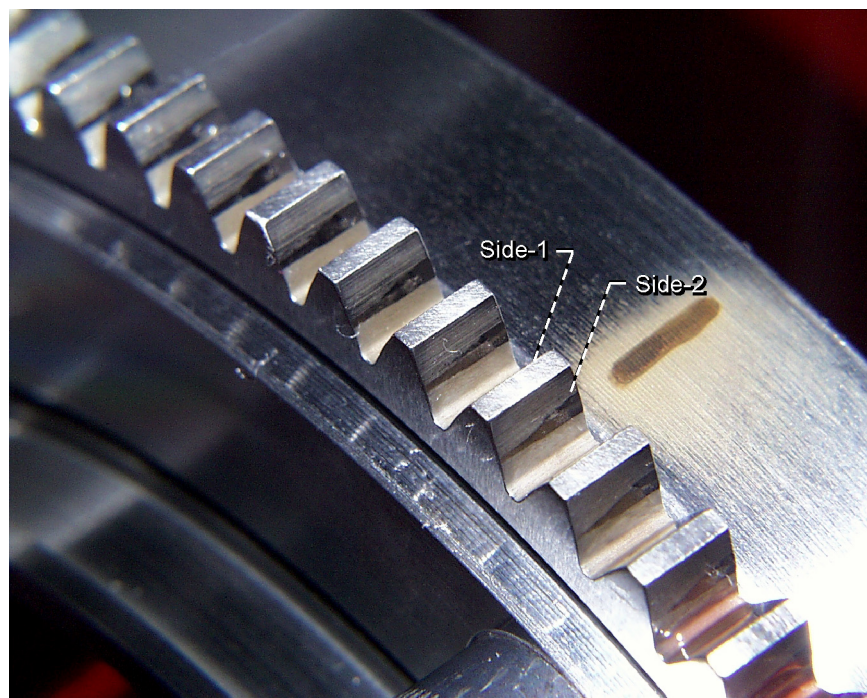
Figure 16.—No visible damage on driving side of ring gear teeth after Score-1 test on side-2, build-1.

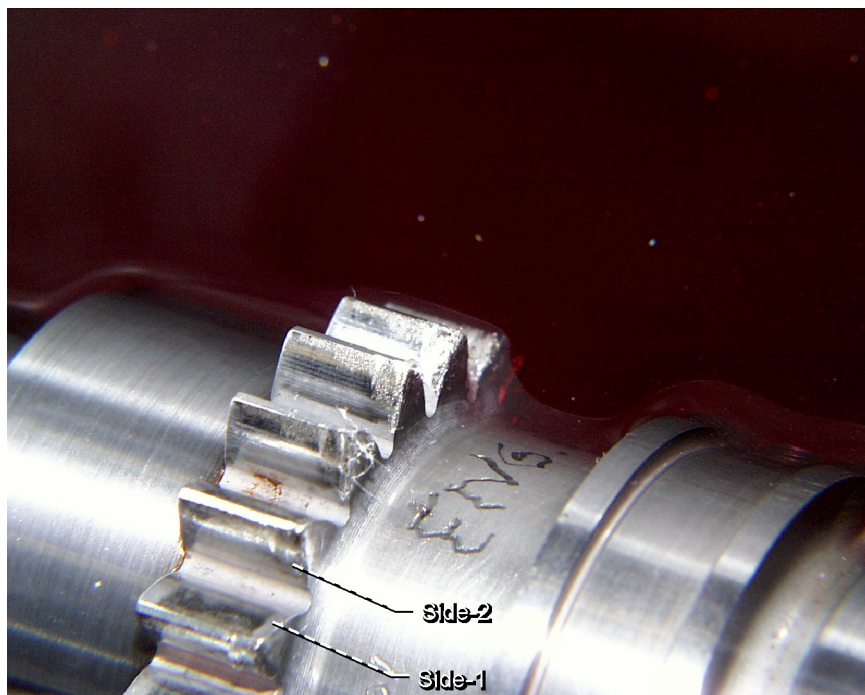
As mentioned previously, during the Score-2 test on side-2, build-1 the gear mesh disengaged at high speed. The resulting damage to the pinion and ring gear teeth is shown in figures 18 and 19, respectively. Note that cloth fibers are visible in these photos. The fibers were created by rough burrs on the damaged gears when the teeth were wiped for photographs.

Figure 18.—Damaged teeth of pinion gear after disengagement at 14,000 rpm pinion speed during the Score-2 test on side-2, build-1. White cloth fibers are caught on teeth from wiping oil.

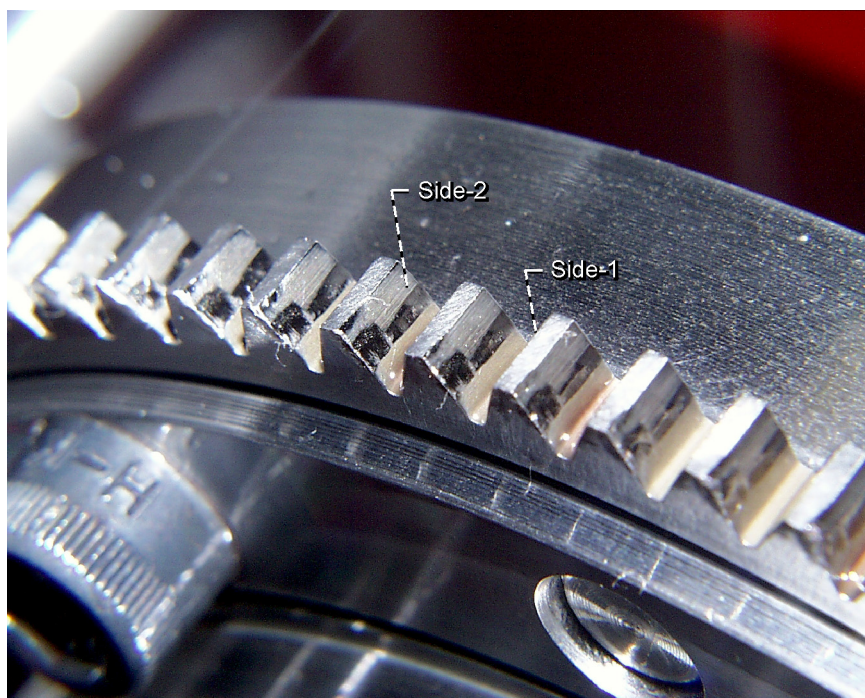
Figure 19.—Damaged teeth of ring gear after disengagement at 14,000 rpm pinion speed during the score-2 test on side-2, build-1. White cloth fibers are caught on teeth from wiping oil.

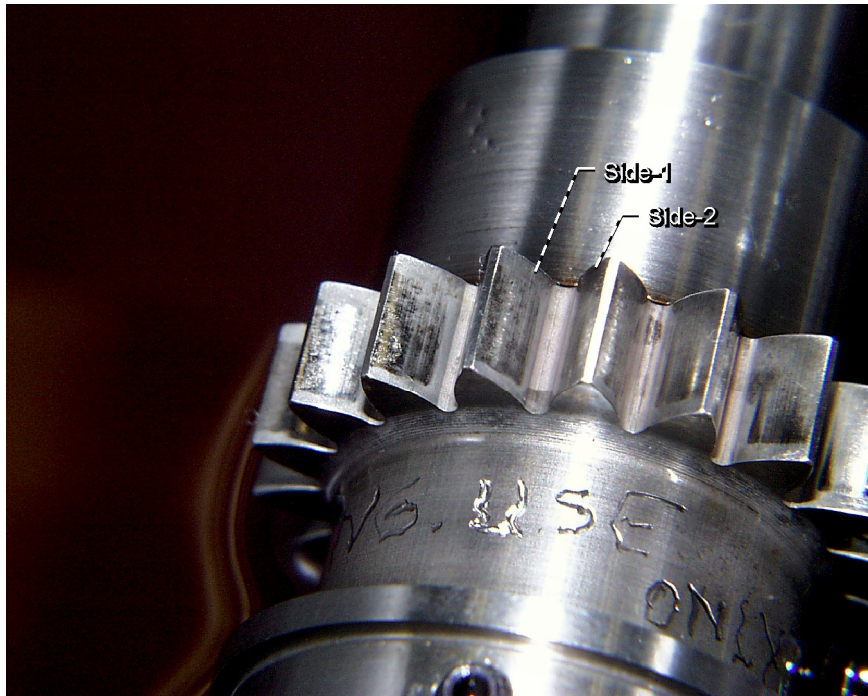
The condition of the pinion and ring gear teeth at the completion of testing (after the Final-5 test) is shown in figures 20 and 21, respectively. The tooth surfaces, including the mild damage created earlier, appear to have been polished.

Figure 20.—Driven side of pinion gear teeth after the test Final-5 are still in good condition.

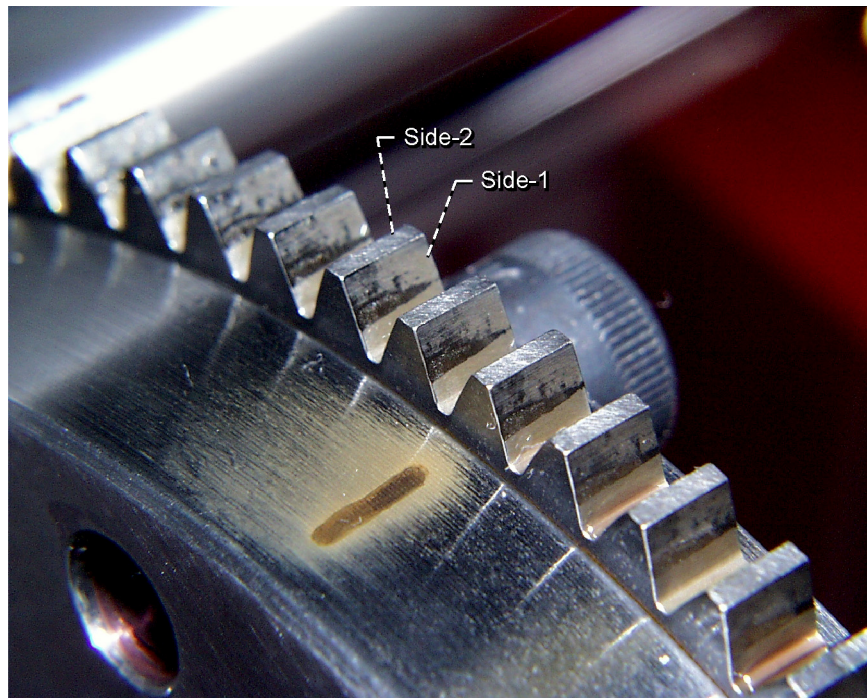
Figure 21.—Driving side of ring gear teeth after the Final-5 are still in good condition.
